Important Service Bulletin for the 2007 Subaru WRX and 2007 Subaru STi Potential Overboost Issues When Operating the Vehicle With a Catless Exhaust System v1.00

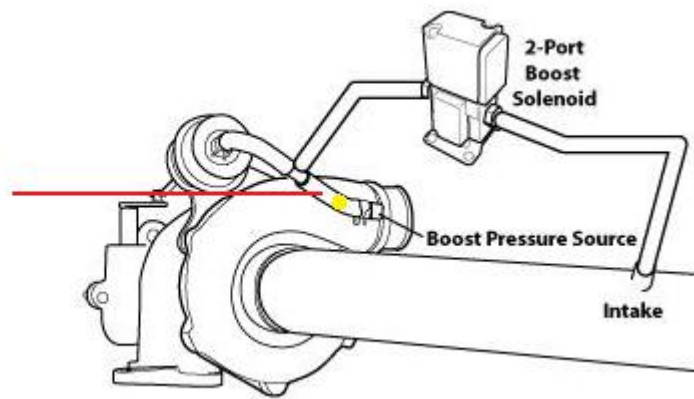
We wanted to educate you about the potential consequences when operating a 2007 WRX or 2007 STi with a catless exhaust system. Subaru has developed a new boost control system on the 2007 Subaru turbocharged vehicles. The major change is the size of the hole in the restrictor pill located in the vacuum line connecting the compressor housing nipple to the vacuum T fitting in the boost control plumbing (see below pictures). Subaru has greatly reduced the size of the restrictor pills on the 2007 WRX and STi from the previous model years. These changes allow for a greater potential for the boost control system to over-run...in other words this is a mechanical function which can promote boost creep when the vehicle is operated with a free-flowing, catless exhaust system.

Carefully remove and replace this vacuum line with the provided replacement vacuum line containing the larger restrictor pill. Be sure to re-use all factory hose clamps.

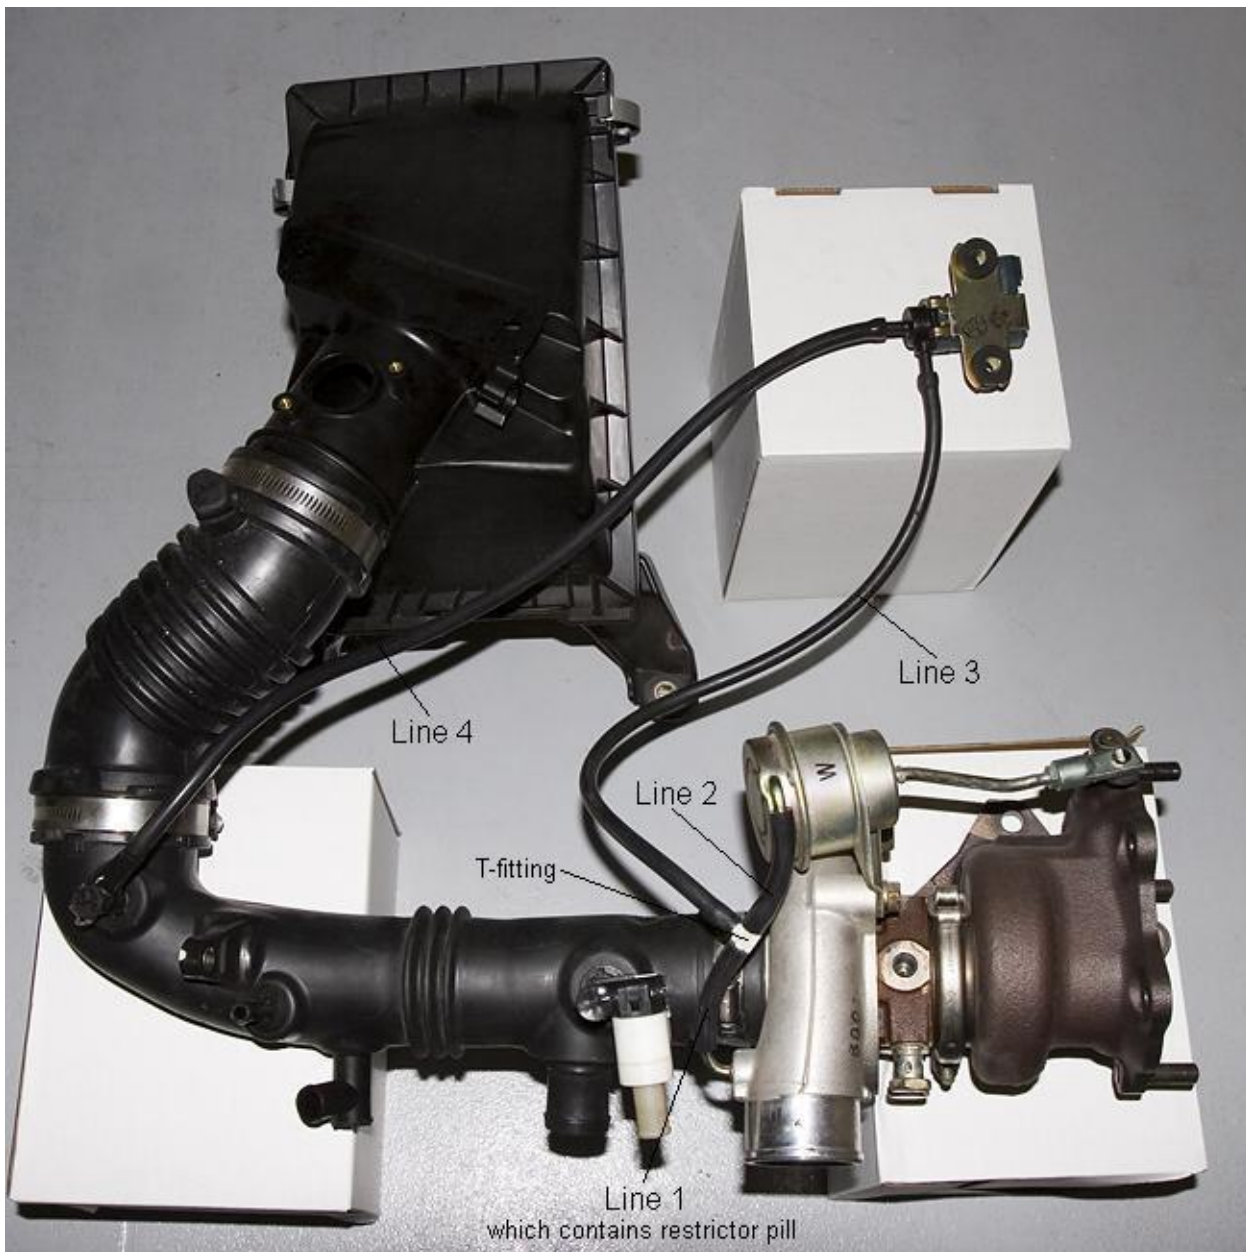
Line 1 plumbs the compressor housing to one end of the T-fitting. This line contains the brass restrictor pill.
